Resin Concrete for Bomb Damage Repair of Airfield Pavements

U S ARMY CONSTRUCTION ENGINEERING RESEARCH LABORATORY
P O BOX 4005
CHAMPAIGN, ILLINOIS 61820

NOVEMBER 1977

FINAL REPORT FOR PERIOD JANUARY 1976-FEBRUARY 1977

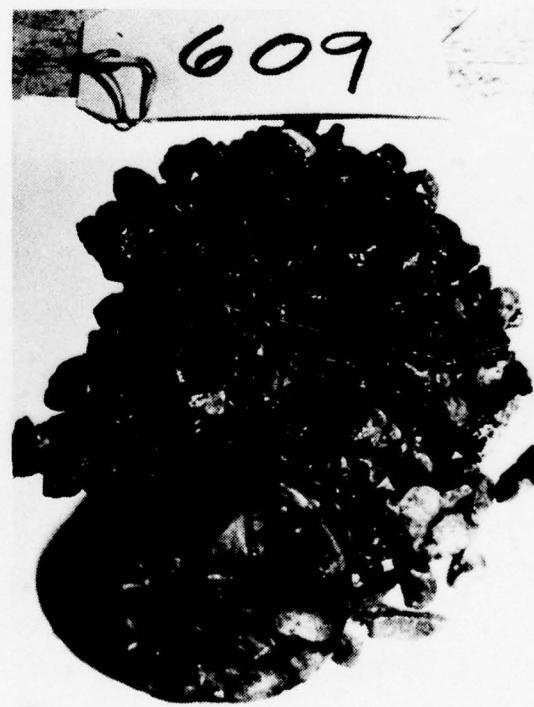
As anticipated, free moisture on the aggregate severely restricted chemical bonding of the resin to the aggregate particles. In the zone of the specimens where the entire void volume was filled with a resin matrix, the complete encapsulation provided mechanical strength even though bonding to the aggregate was not good.

Figure 9. Failure of Celanese Epoxy Resin to Cure in Presence of Moisture

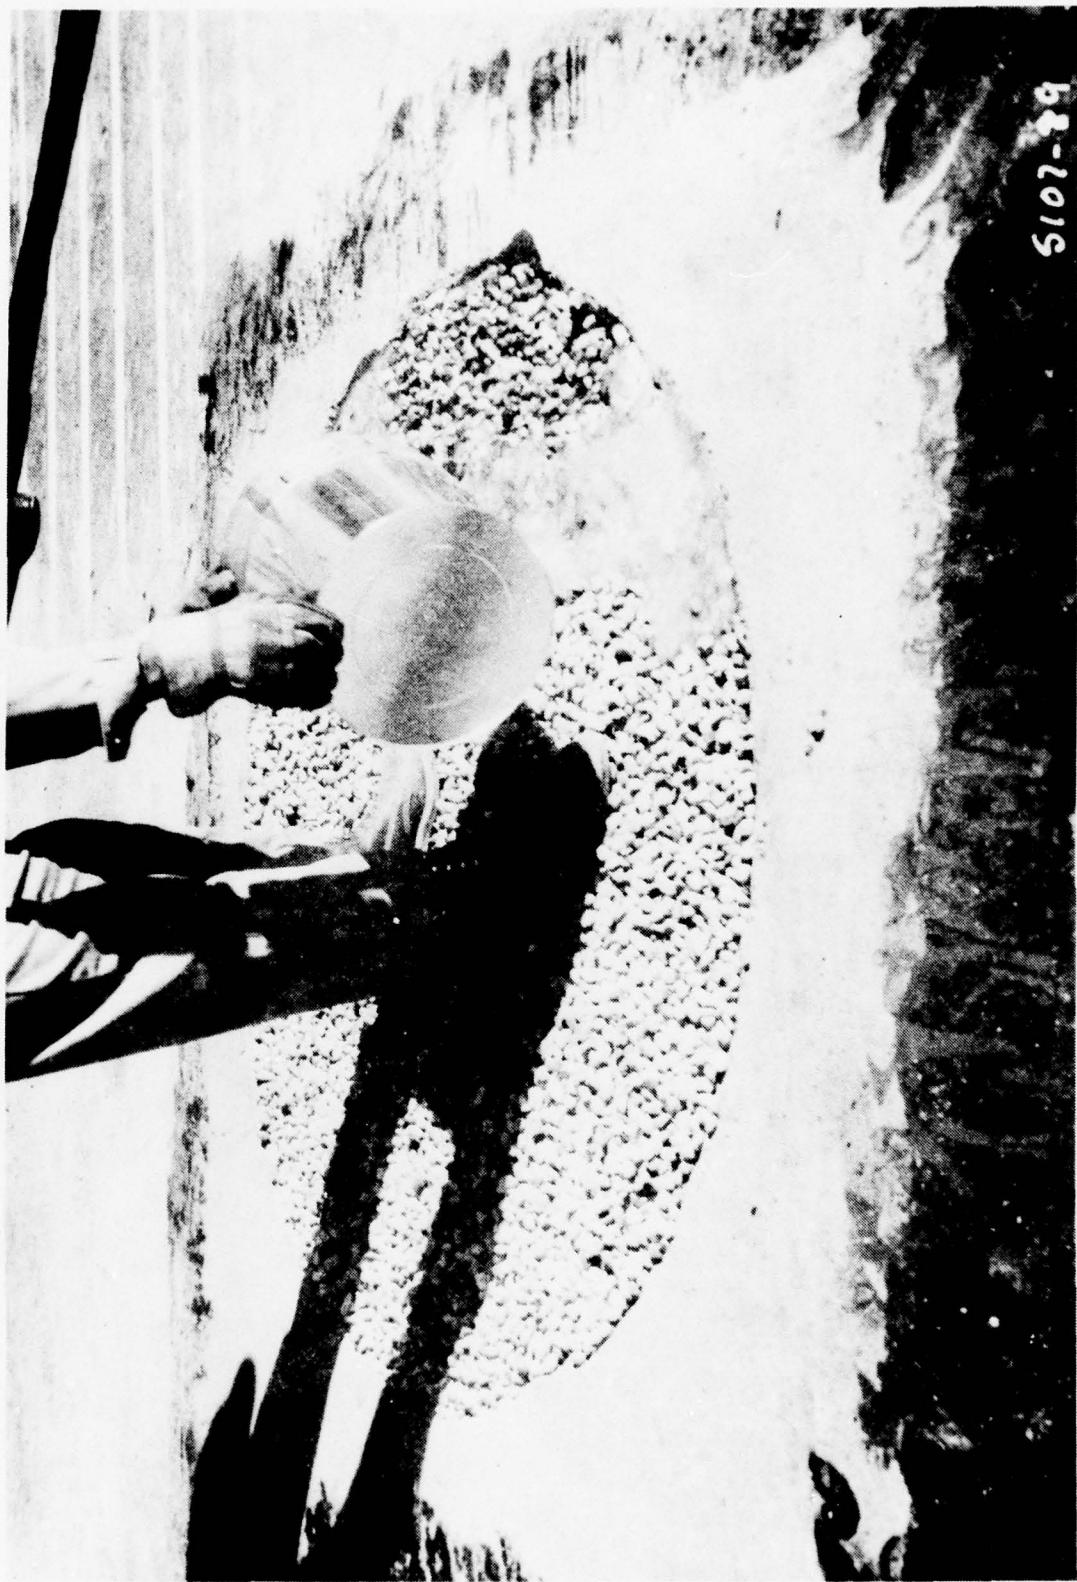
Figure 38. Application of Epoxy Resin Mixture

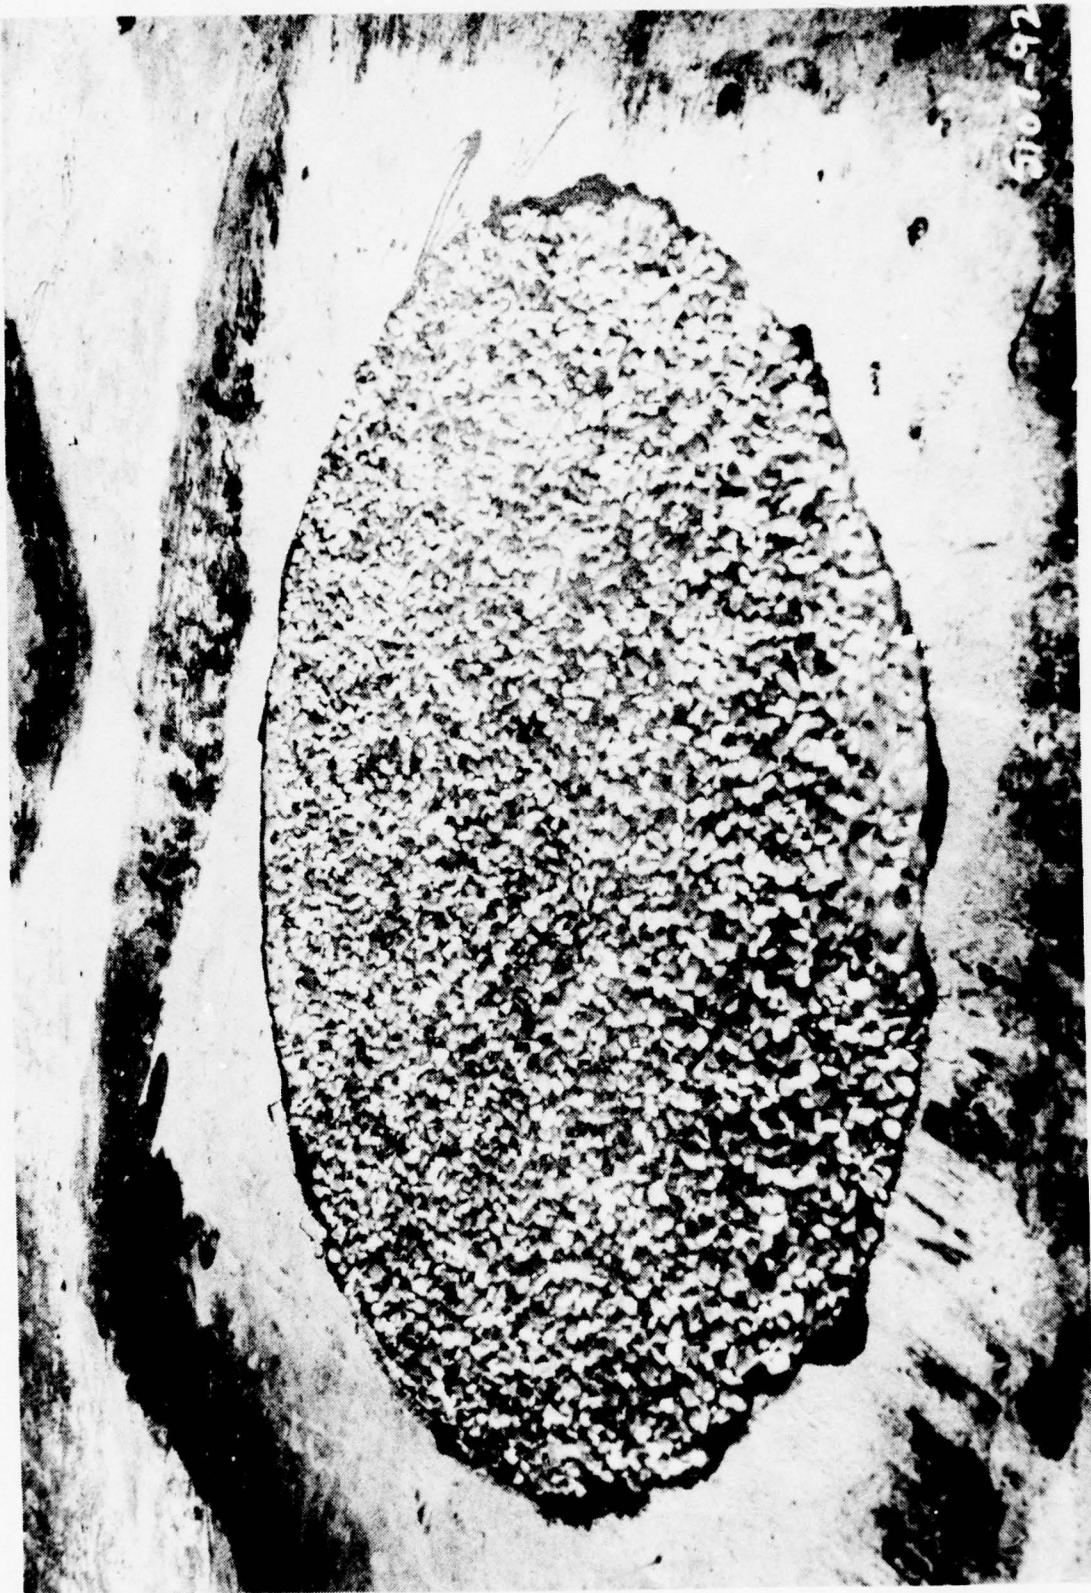
Figure 39. Cured Epoxy Repair Cap

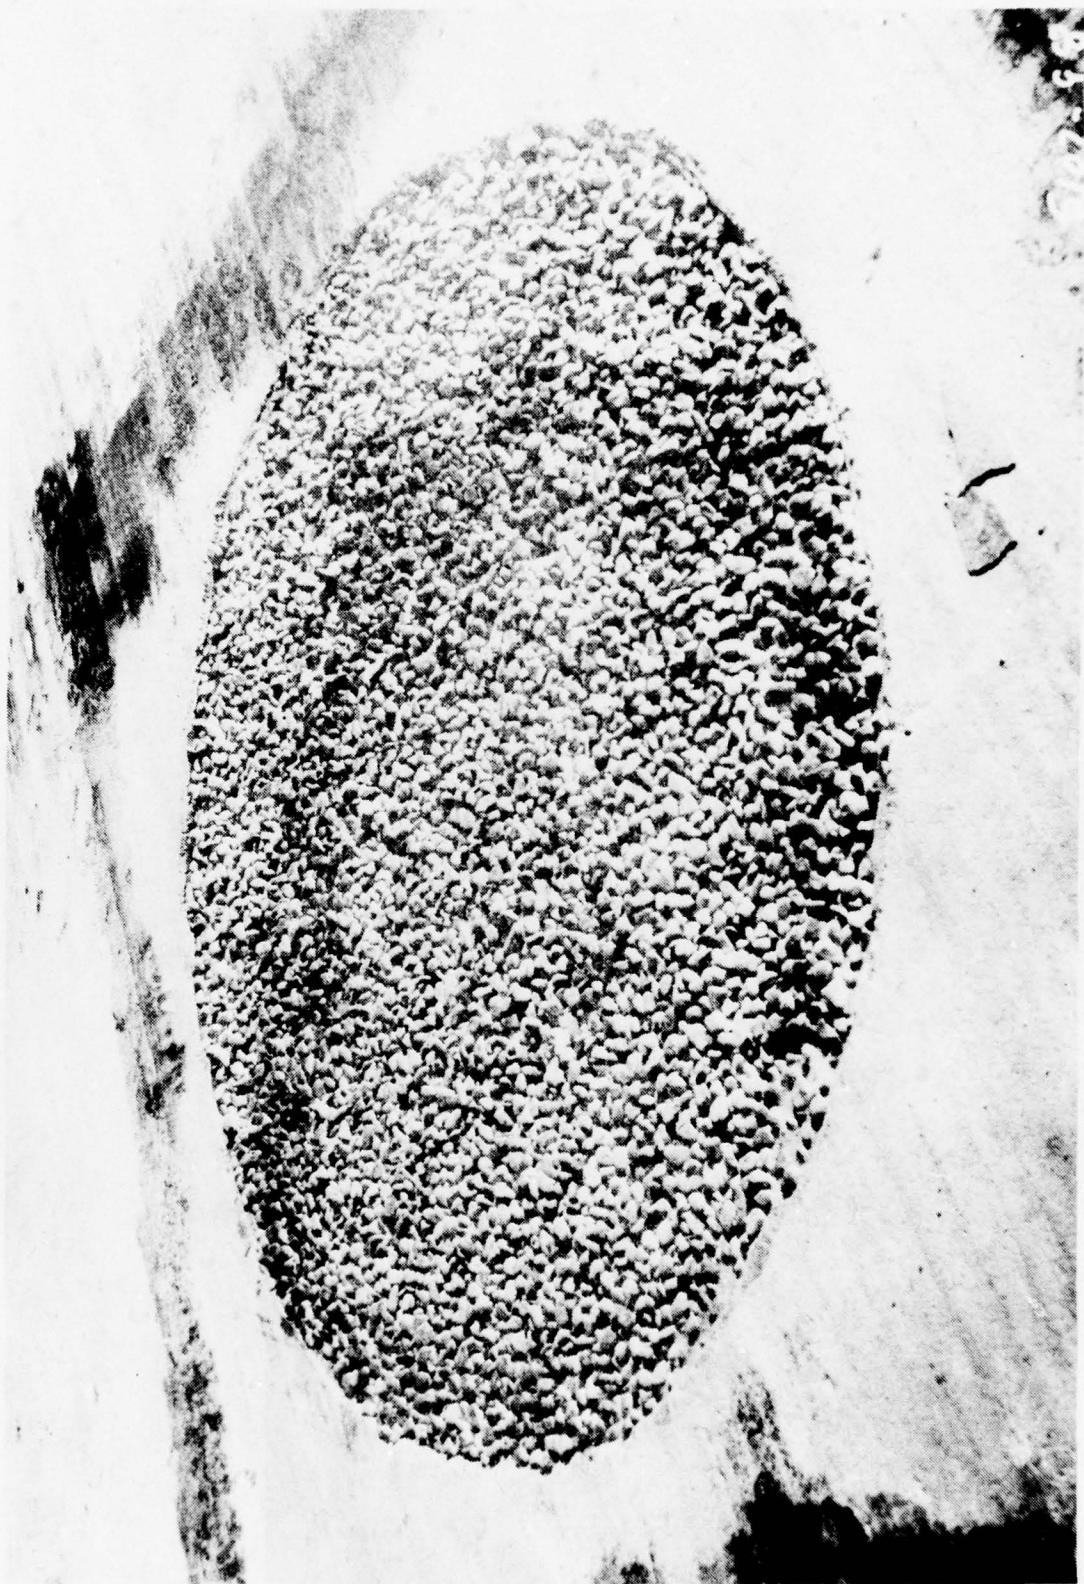
drier than had been used during the first test. The test patches were traffic-tested 30 minutes after the application of resin. The epoxy patch sustained passage of the load cart without obvious distress or failure during 100 passes. However, some of the aggregate ravelled from the surface of the repair and some of the pieces that projected above the surface broke off. It was judged that completely filling the void volume in the aggregate with resin would have minimized the release of aggregate. The Polyproducts material performed satisfactorily in the demonstration test. Figures 36 through 40 show the preparation and testing of the epoxy repair patches. The ravelling is shown in Figure 41. The first two tests were conducted in sunny weather at about 75°F (24°C) with slight wind.

Figure 40. Epoxy Repair Cap After Required Test

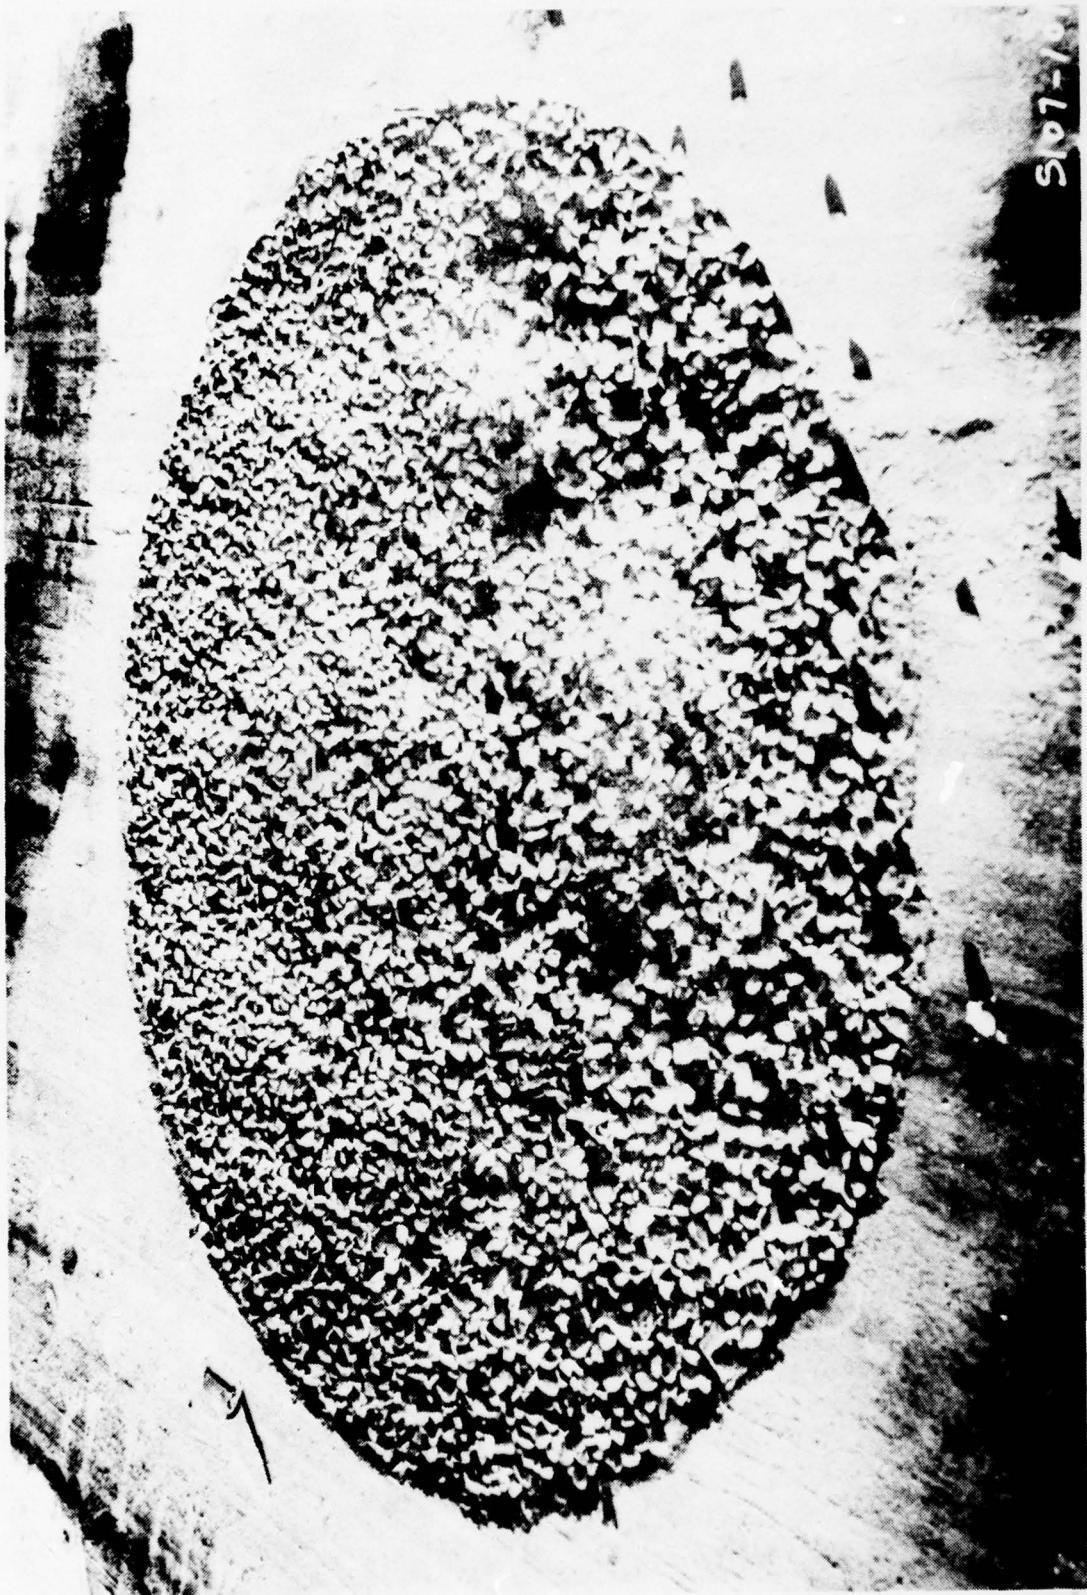
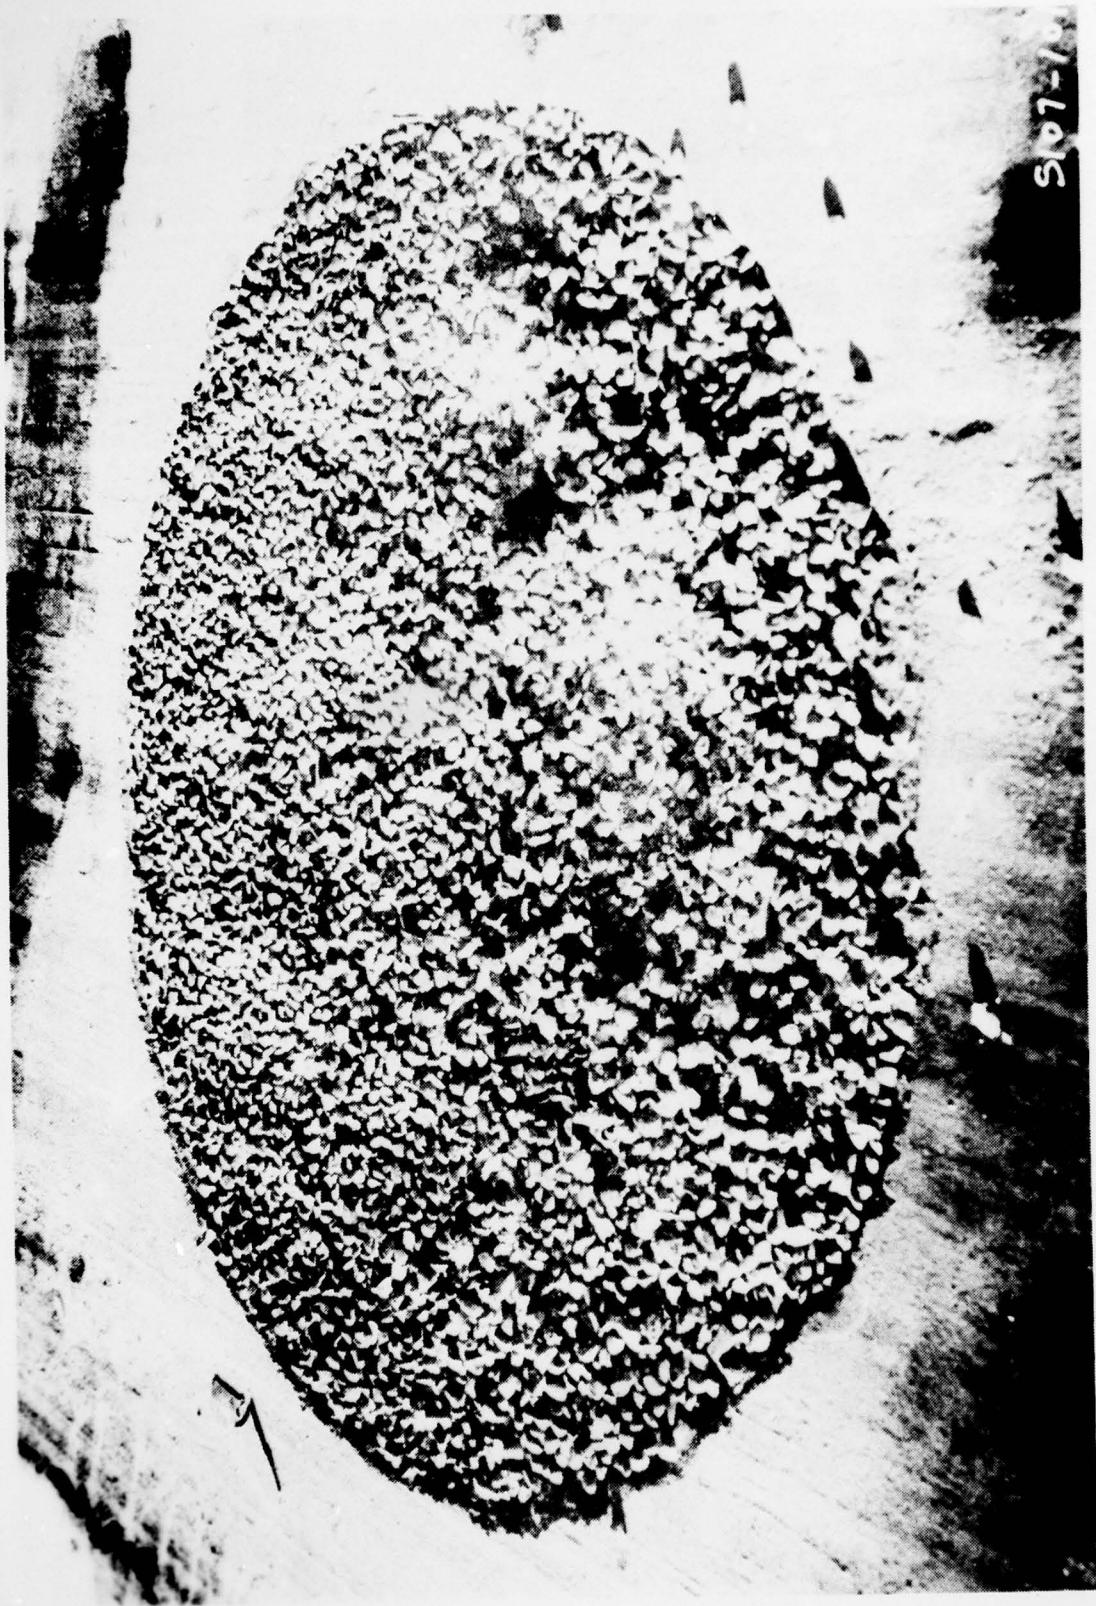
Figure 41. Additional Loading Series Produced Ravelling (Loose Aggregate)

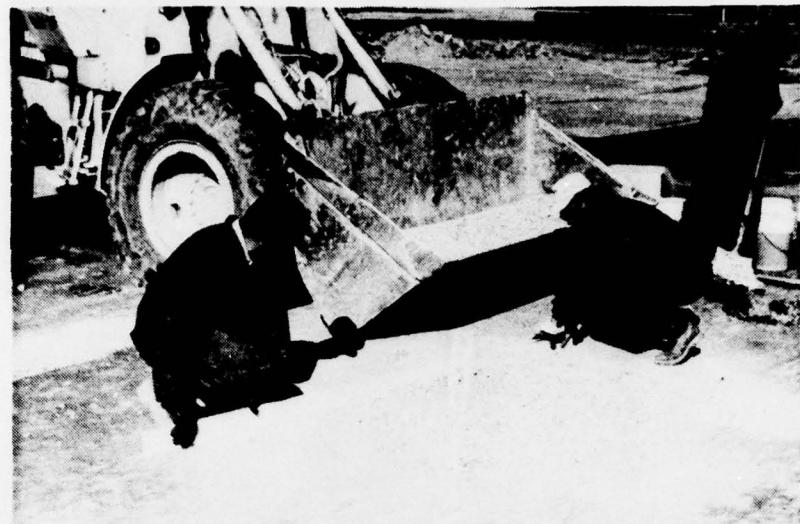
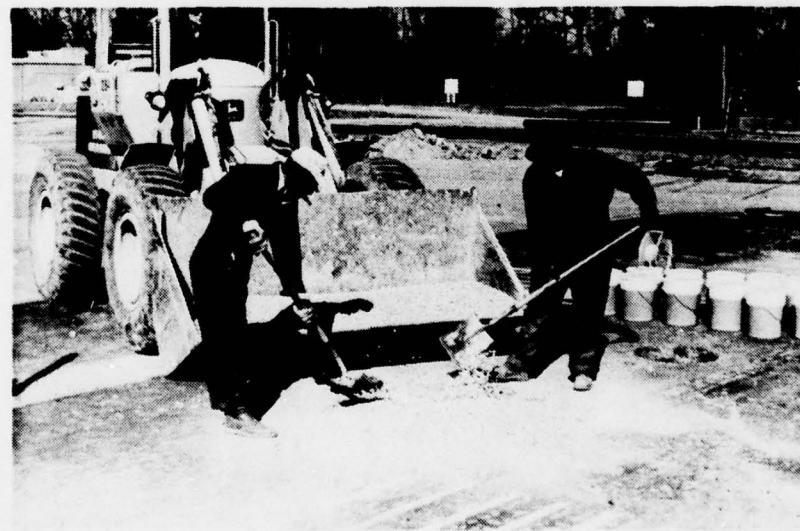
Figure 42. Preparation of Polyester Repair Cap
(Intermediate Crater)

Figure 42. Preparation of Polyester Repair Cap
(Intermediate Crater) (Concluded)

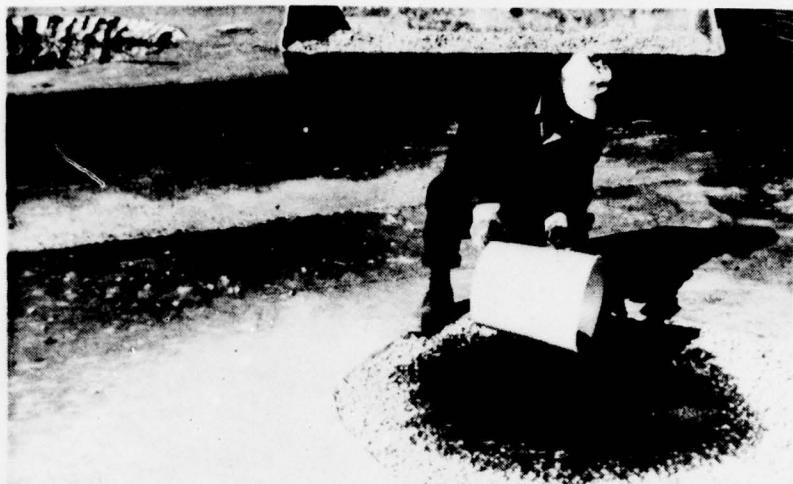
Figure 45. Application of Polyester to Aggregate

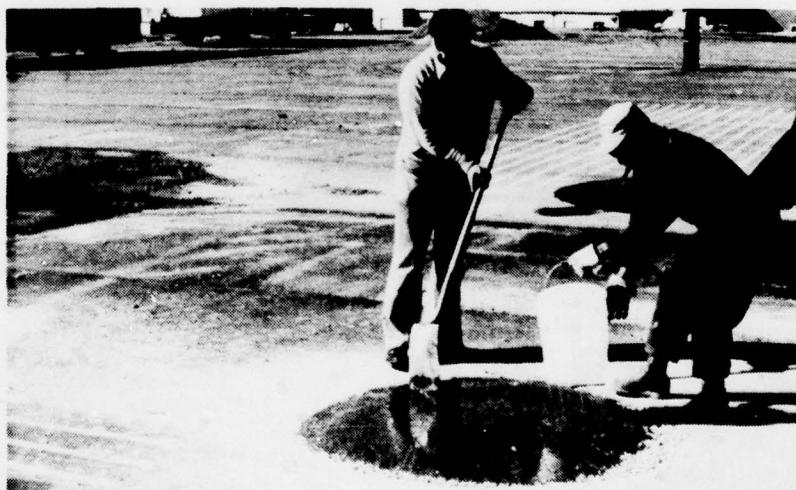
Three repair patches were made: one each in a small and an intermediate crater in which the resin was allowed to permeate the whole aggregate fill (Figures 42 through 46) and one in a large crater. In the latter repair the crater was filled with dry aggregate to within about 6 inches (0.15 meter) below the pavement surface (Figure 47). After levelling this fill, two layers of fiberglass woven roving were placed on top of the fill (Figure 48). Additional dry aggregate was placed on top of the fiberglass and levelled with the pavement surface (Figure 49). Each patch was filled with resin mixed in 35-pound (16-kg) batches and poured on top of the aggregate until the void volume was filled. Excess resin was inadvertently applied to each patch, causing a slight ponding of resin (Figure 50). In all three tests it was impossible to judge when the voids were filled because the fluid pooled on the surface and seeped slowly down. This represents a problem with this approach. Other steps, such as sanding the surface after the resin is applied, might alleviate the problem as well as provide a smoother patch surface.

Figure 46. Attempt to Remove Excess Resin

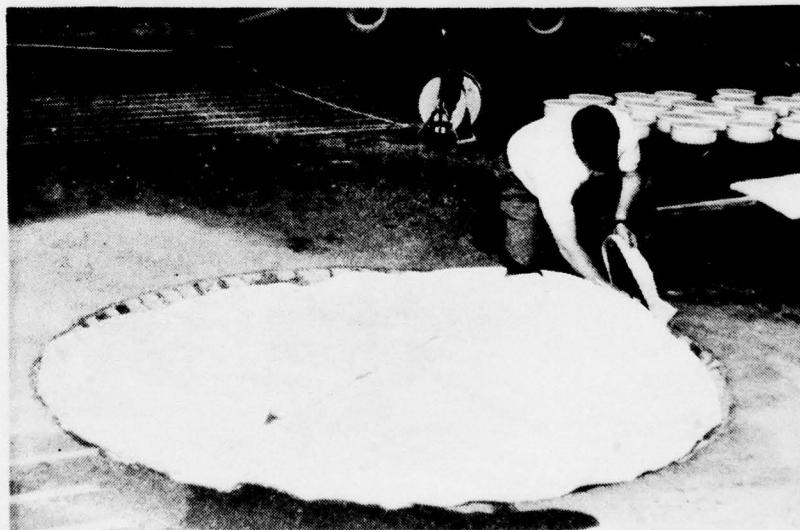
Figure 48. Installation of Fiberglass Cloth in Large Crater

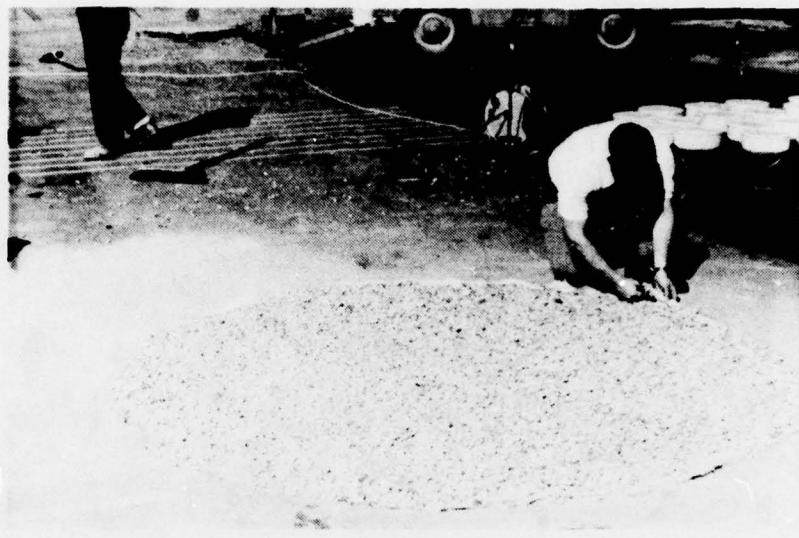
Figure 49. Final Layer of Aggregate in Large Crater

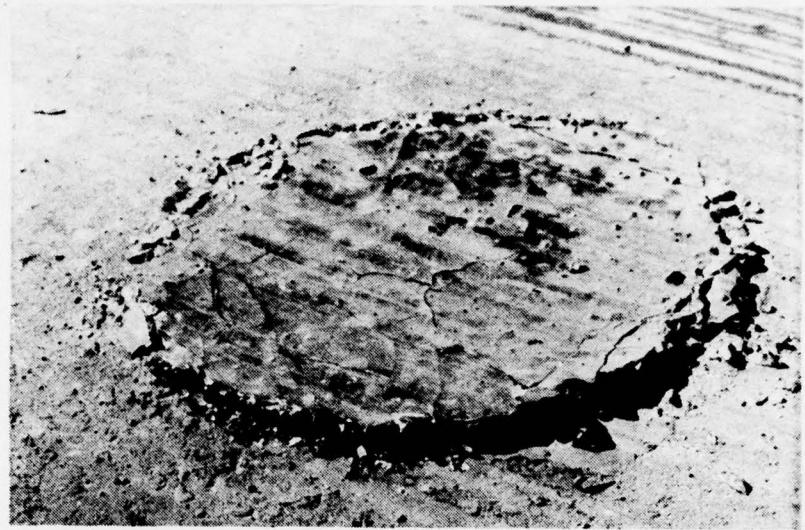
Figure 53. Small Crater Polyester Repair Did Not Bond to Edges

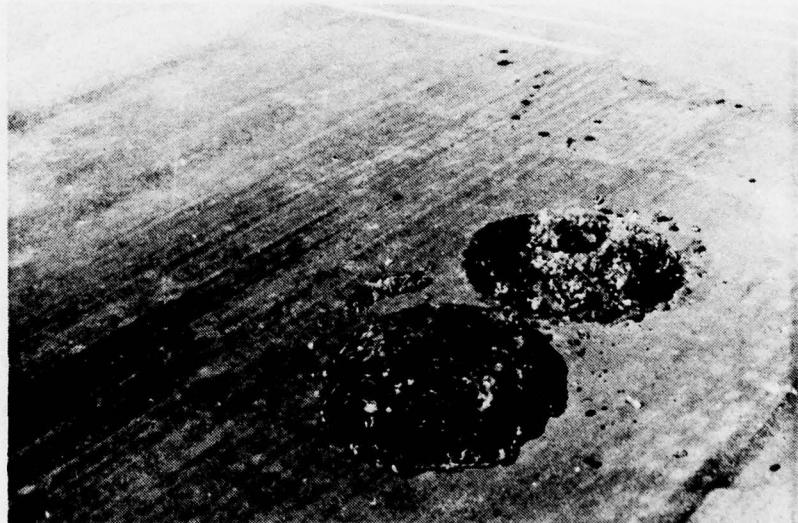
Figure 54. Small Crater Repair Removed

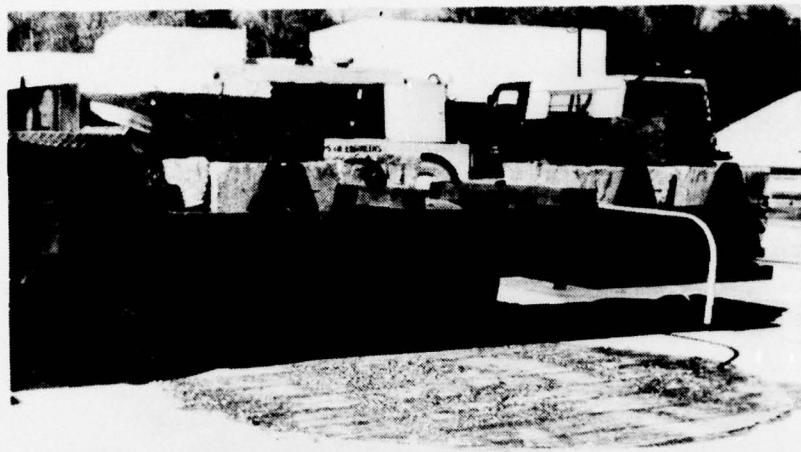
Figure 55. Large Crater Polyester Repair During Test Sequence
